CLAY EXTRACTION MANAGEMENT PLAN and EIL RENEWAL

LOT 1 MORANGUP ROAD, MORANGUP

PREPARED FOR
AUSTRAL BRICKS (WA) PTY LTD

AUGUST 2023

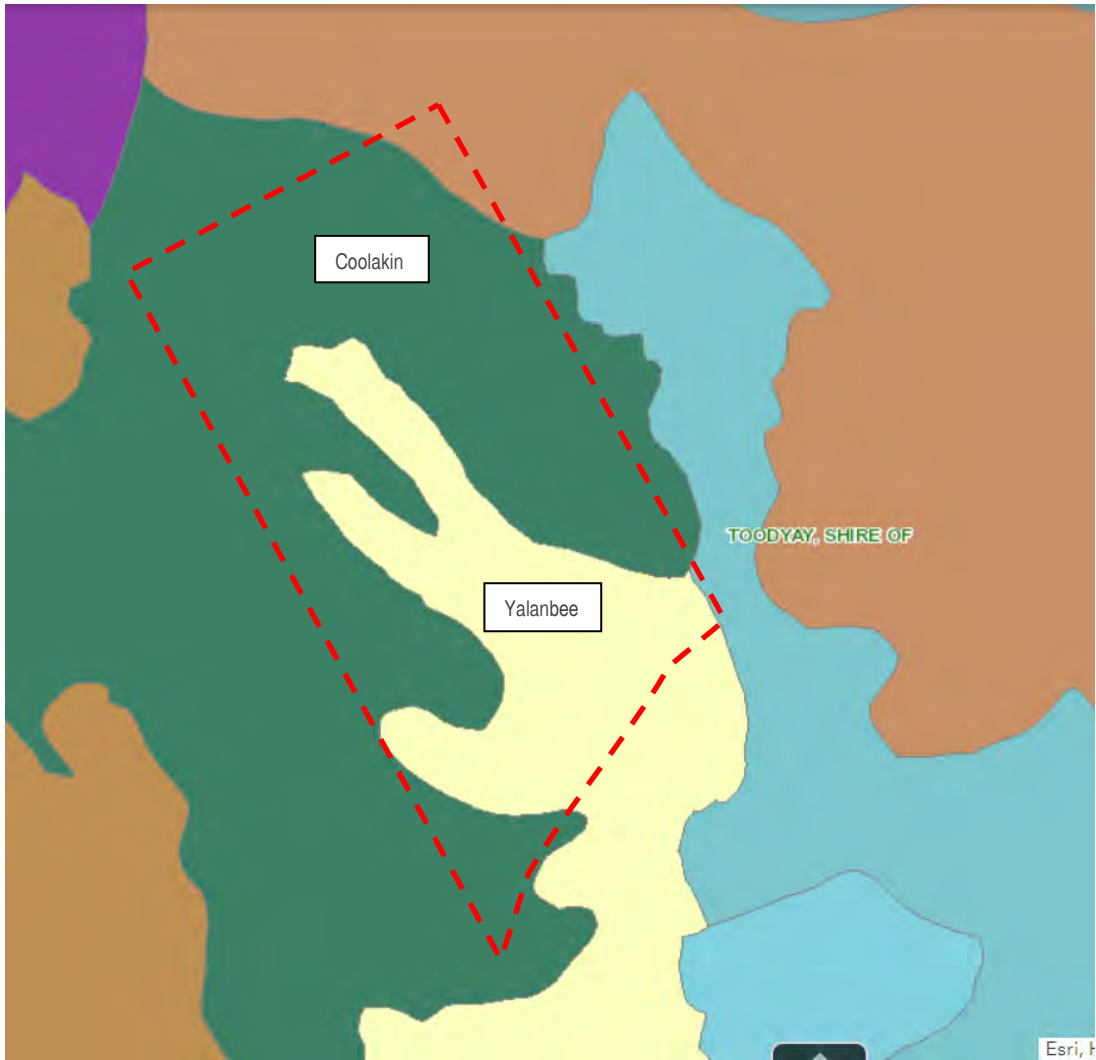
Figure 4 – Vegetation Complexes

There are two vegetation complexes mapped across the site as follows and shown in Figure 4.

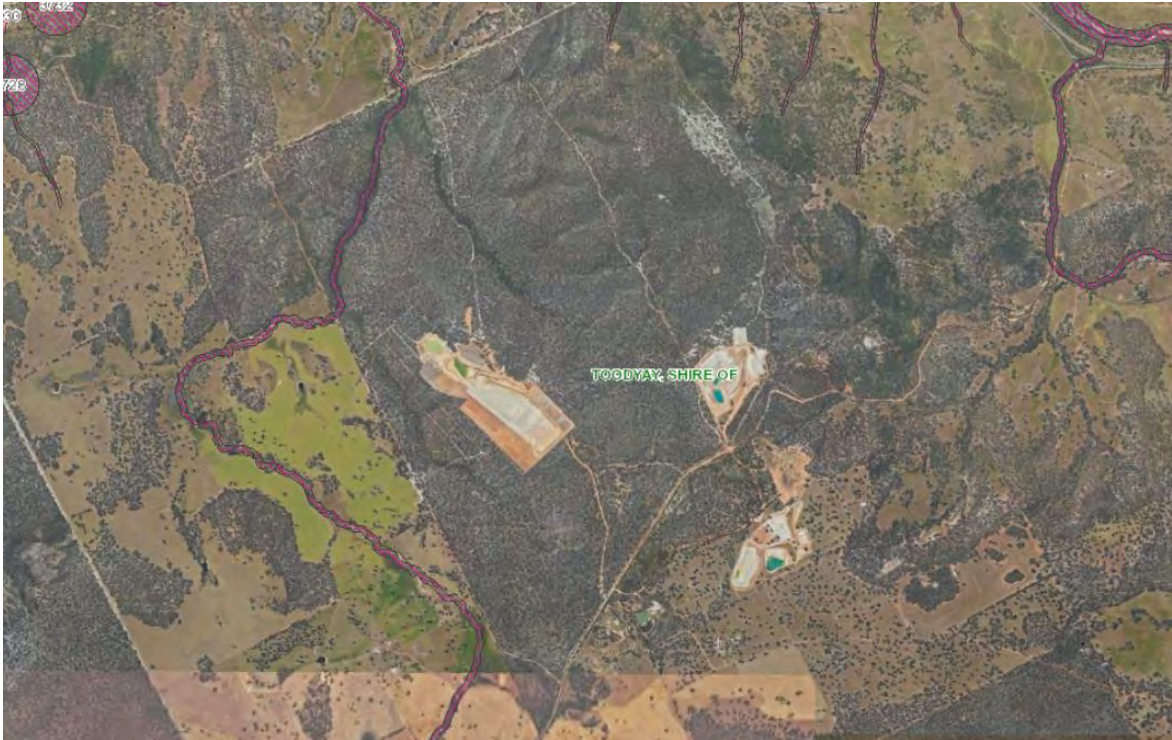
Figure 5 – Aboriginal Heritage Places

A search of the Aboriginal Heritage Database indicated that there is one Registered Heritage Sites located on the site. This site is the “Avon River” (ID 15979) and is mapped across the Morangup Brook (which is located across the north-western corner of Lot 1). The heritage site is located at least 550 metres from the operation and will not be directly disturbed by the excavation. Water management on site will protect the watercourse and heritage site from indirect impact. There are no Other Heritage Sites located on or directly surrounding the operation. The Registered Heritage Site is shown in Figure 5 below.

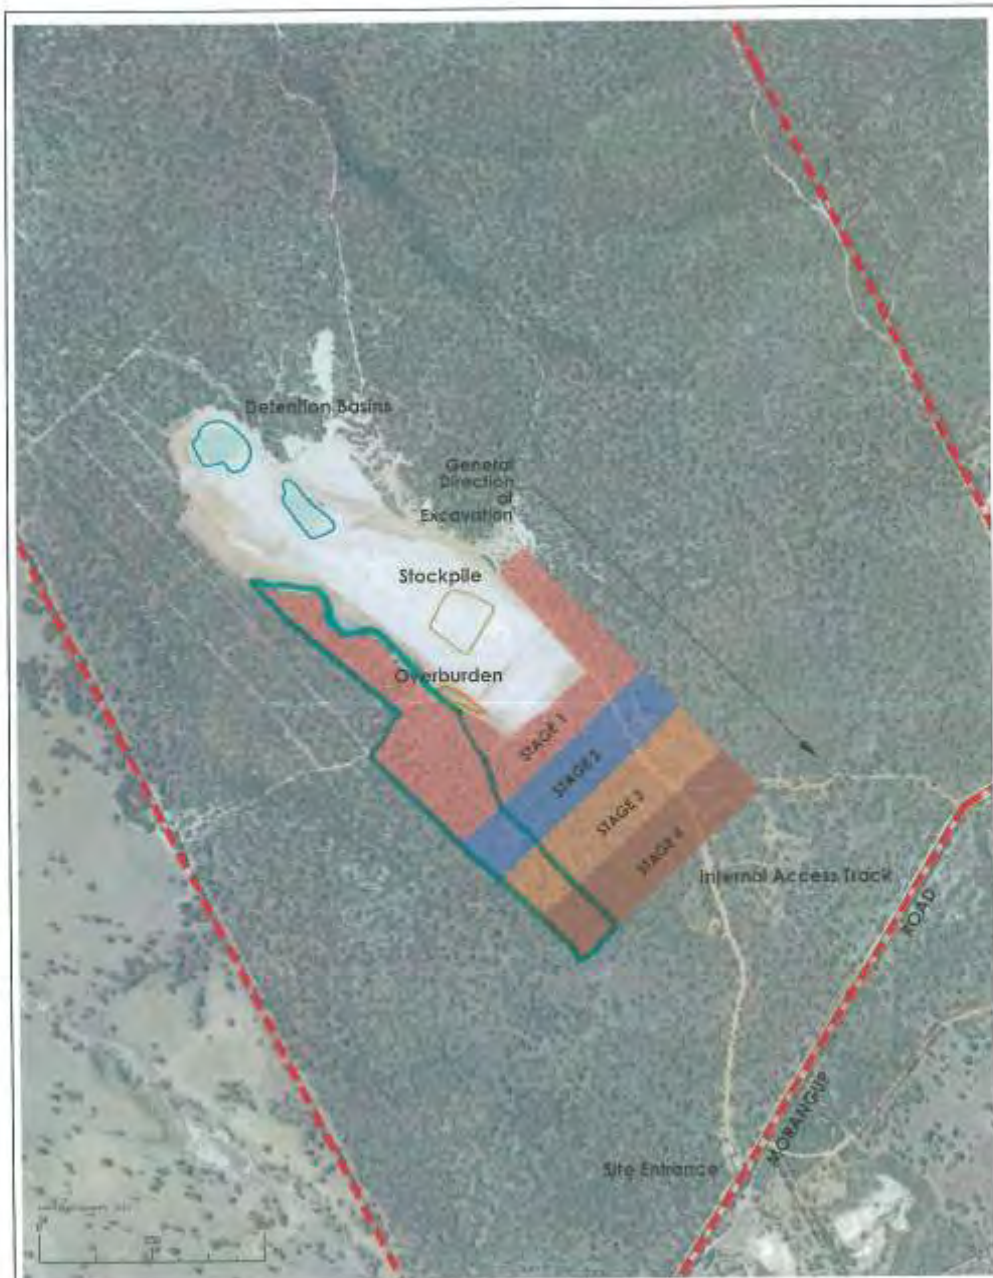
FIGURE 3 NEW EXCAVATION AREA, OUTLINED IN GREEN

This report is the result of a spring botanical survey of the flora and vegetation on the site. The location of the property is shown in **Figure 1** and the extent of the property is shown in **Figure 2**. An additional area was added to the site in 2013, this is shown on **Figure 3** and has been included as part of this report.

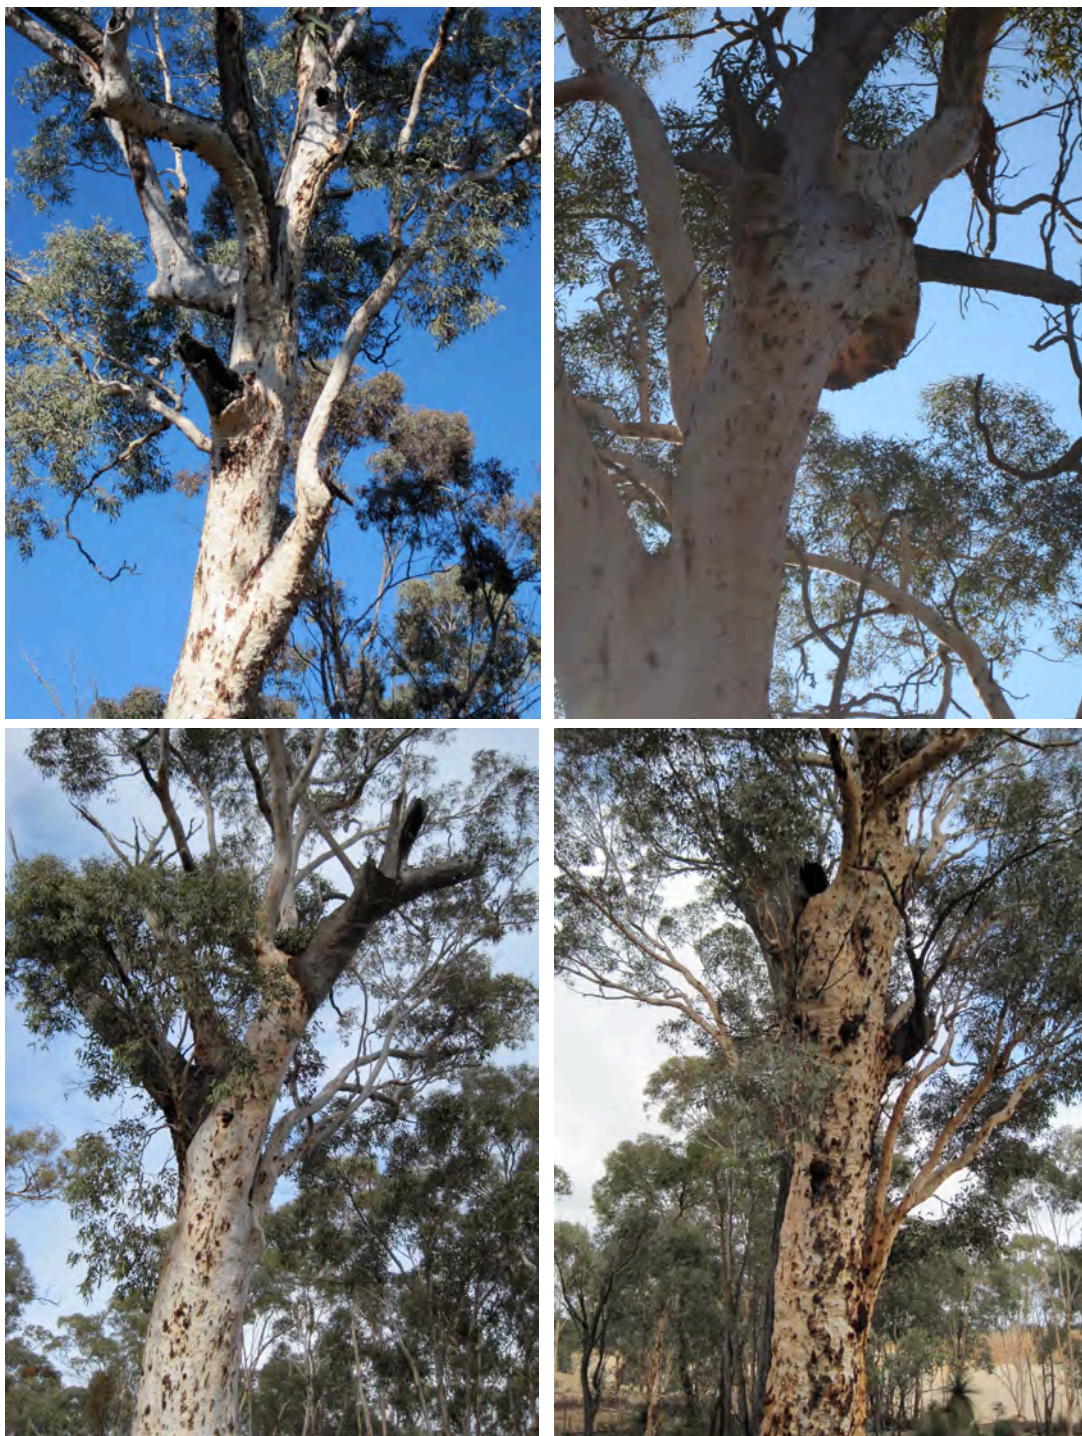
Plate 7. Trees with potential black-cockatoo hollows.

In the study area, Carnaby's Black-Cockatoo may potentially use Wandoo, Powderbark Wandoo, or Marri trees for breeding, and though they favour smooth-barked eucalypts, they may potentially use any suitably-sized hollow (Johnstone and Storr 1998, DSEWPaC 2012). The Forest Red-tailed Black-Cockatoo is only likely to use hollows in Marri and possibly Wandoo (Johnstone and Storr 1998). Overall, 708 trees were identified that demonstrated a DBH \geq 50cm (Figure 4). One hundred of these trees appeared to have at least one large existing hollow potentially suitable for cockatoos, with one of these rendered unsuitable by the presence of Feral Honeybees. The majority of the large tree hollows were located in the Wandoo woodland to the east of the existing pit, but there were large hollows throughout the study area (Plate 7).

The presence of trees with a DBH \geq 50cm indicates that the study area is potential breeding habitat for both black-cockatoo species (DSEWPaC 2011). Although no evidence of breeding was found (e.g. chewed hollow entrances), Carnaby's Black-Cockatoo potentially nests in the study area. The Bindoon – Julimar Important Bird Area (IBA) consists of 52,480ha of native vegetation about 11km north of the study area, and this area is listed as an IBA due to the large number of Carnaby's Black-Cockatoos nesting in the area (Birdlife International 2012). The Forest Red-tailed Black-Cockatoo may potentially nest in the study area, though this species is at the northeast limit of its range in the area.

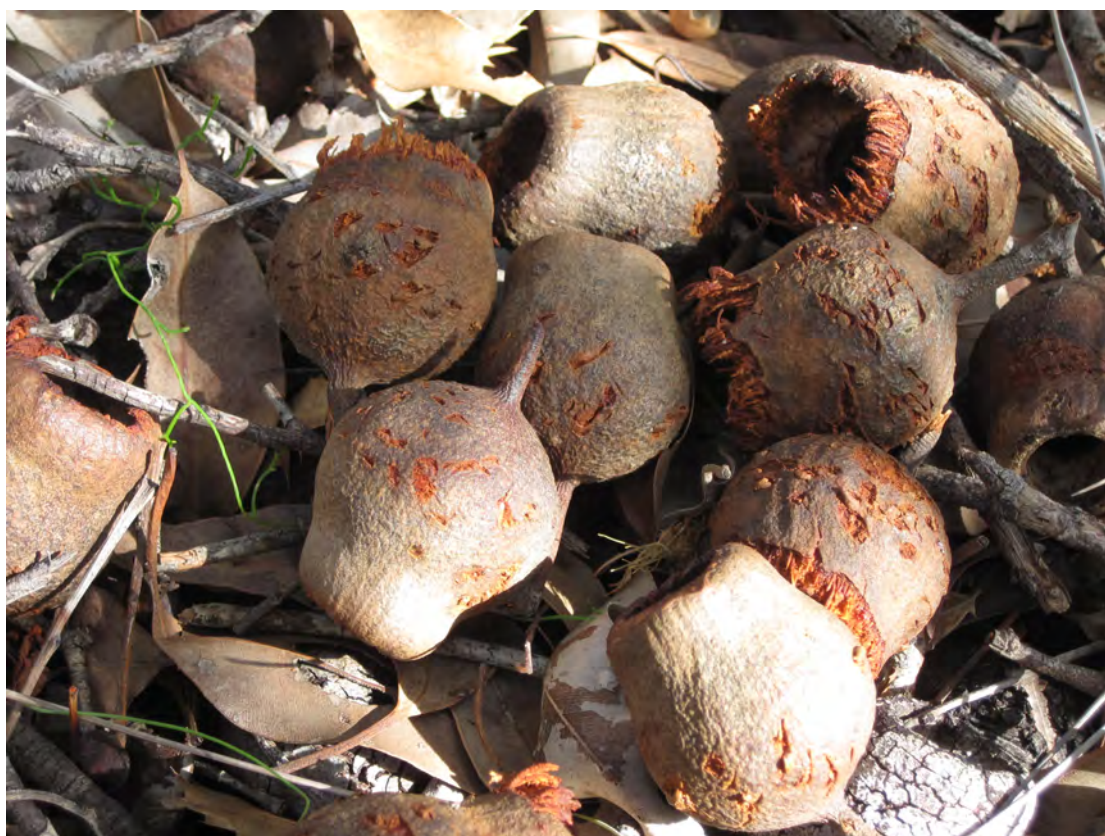
Plate 8. Marri nuts chewed by Carnaby's Black-Cockatoo.

The study area represents foraging habitat for the Forest Red-tailed Black-Cockatoo, Baudin's Black-Cockatoo and Carnaby's Black-Cockatoo. Marri, Jarrah, Wandoo and Powderbark are the dominant trees in the study area and these species are sources of food for all three cockatoo species. Carnaby's Black-Cockatoos were observed foraging on Marri seeds in the study area during the site visit, and evidence of foraging on Marri showing characteristic marks on Marri fruits (Plate 8) was observed throughout the study area.

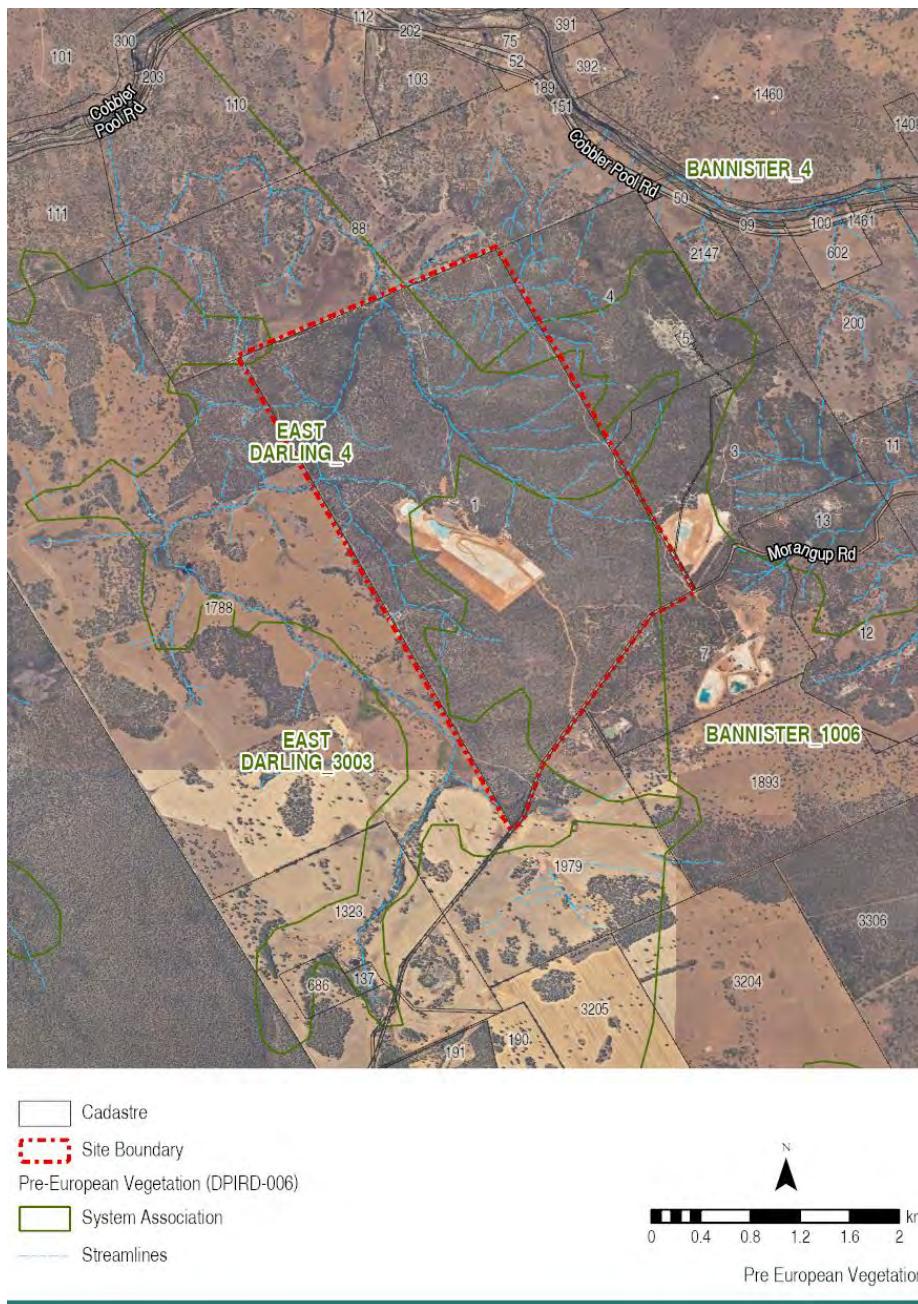
Figure 2 – Pre-European Vegetation Mapping

The pre-European vegetation complex is mapped by the Department of Biodiversity, Conservation and Attractions (DBCA) on the SLIP database based on the mapping undertaken by Mattiske and Havel (1998). There are two vegetation complexes mapped across the site:

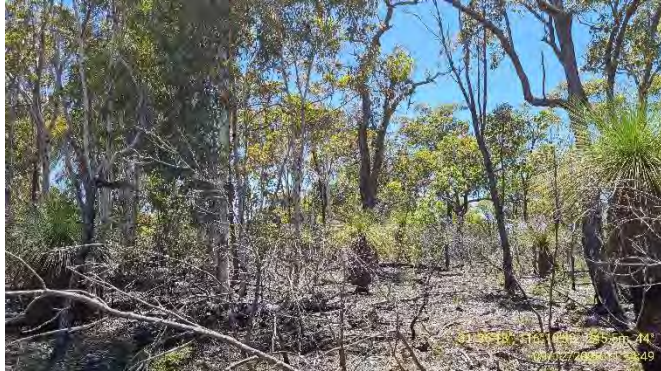
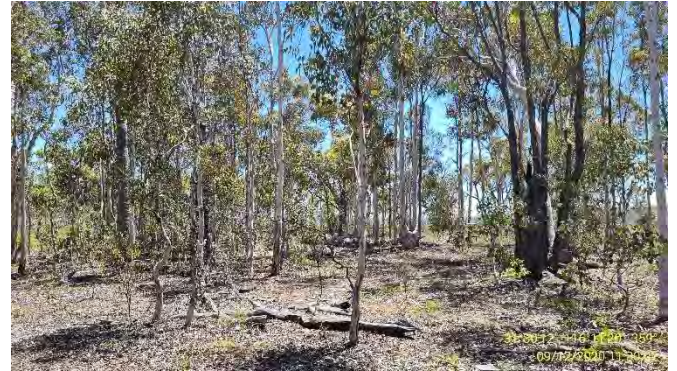
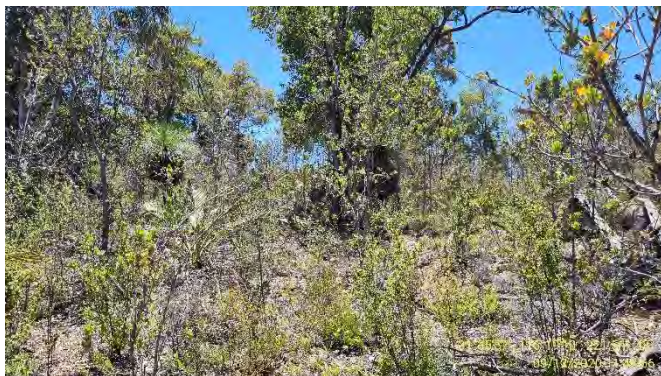
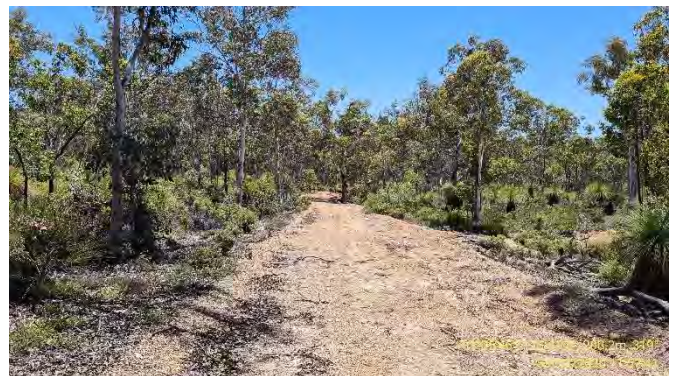
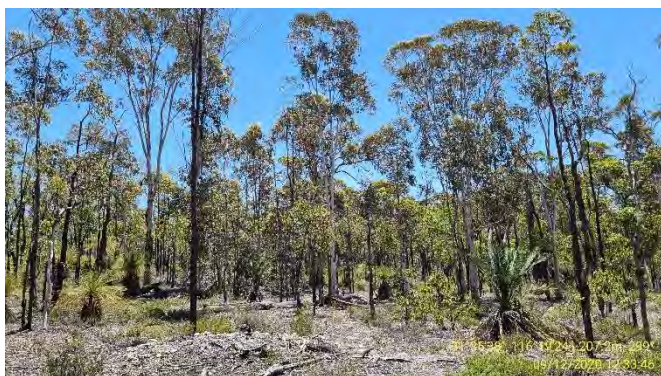
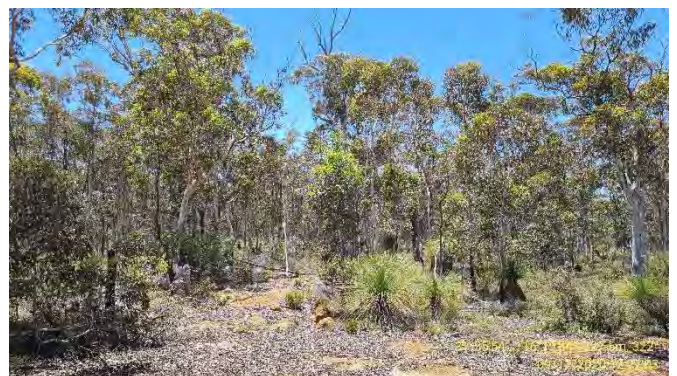
Marris, jarrah, wandoo with average height of 12-15 metres and foliage cover of approximately 30%. Saplings, dryandra and grass trees and low heath understorey, sparse in areas.

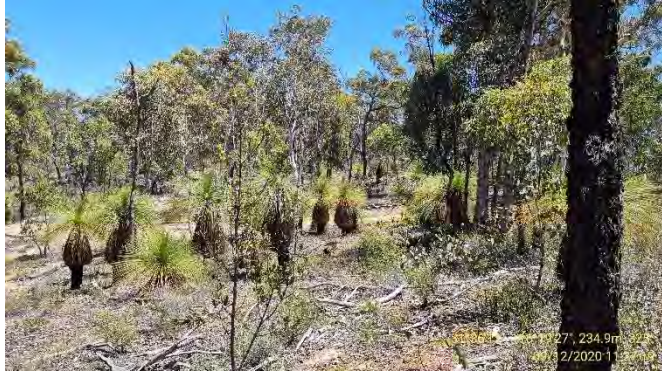
Photo ID: 3a

Vegetation Types Present:	Open forest A-03
---------------------------	------------------

Description/Justification:	Marris, jarrah, wandoo with average height of 12-15 metres and foliage cover of approximately 30%. Saplings, dryandra and grass trees and low heath understorey, sparse in areas.
----------------------------	---

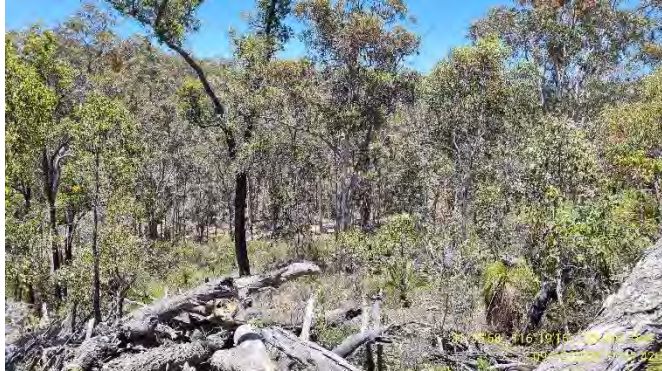
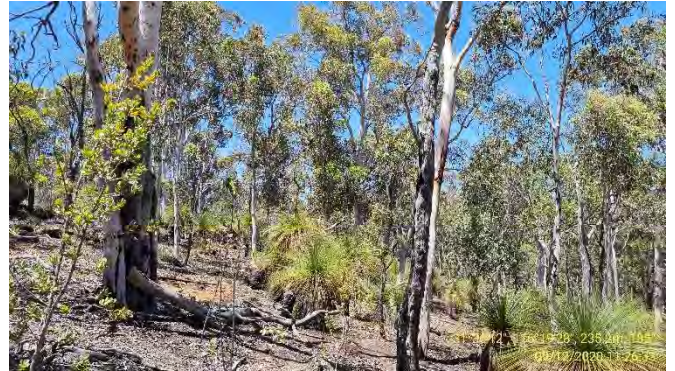
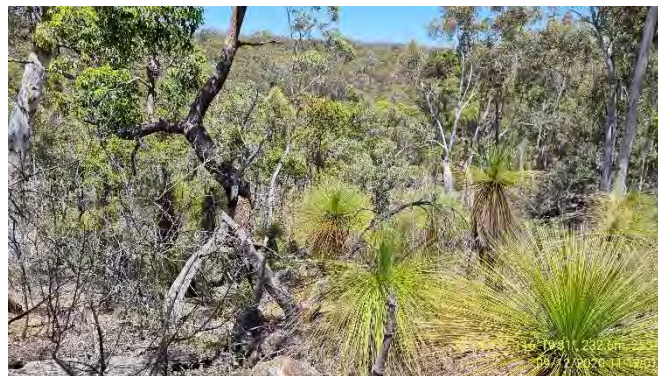
Vegetation Types Present:	Open forest A-03
---------------------------	------------------

Description/Justification:	Marris, jarrah, wandoo with average height of 12-15 metres and foliage cover of approximately 30%. Saplings, dryandra and grass trees and low heath understorey, sparse in areas.
----------------------------	---

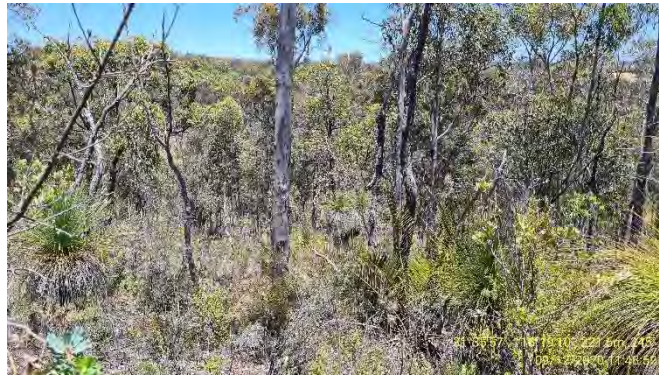
Photo ID: 5a

AS 3959:2018 Vegetation Classification Applied:	Class A Forest
Vegetation Types Present:	Open forest A-03
Description/Justification:	Marris, jarrah, wandoo with average height of 12-15 metres and foliage cover of approximately 30%. Saplings, dryandra and grass trees and low heath understorey, sparse in areas.

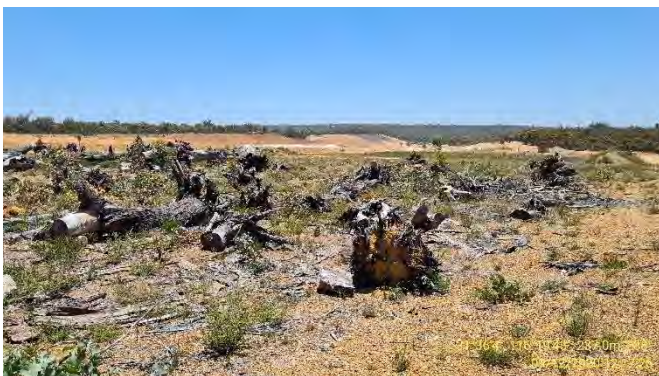
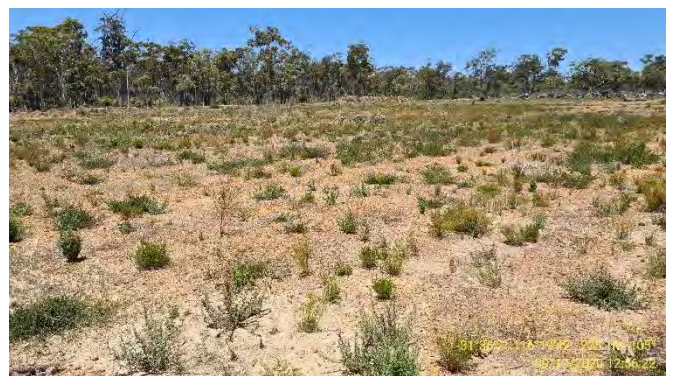
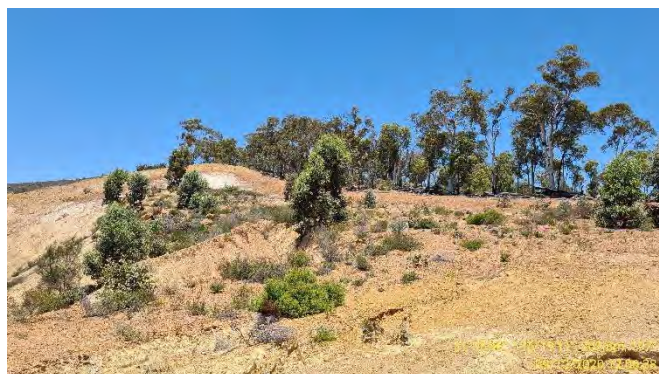
AS 3959:2018 Vegetation Classification Applied:	Class C Shrubland
Vegetation Types Present:	Open heath C-11
Description/Justification:	Areas of revegetation. Low shrubs, assessed in mature state as Open Heath.

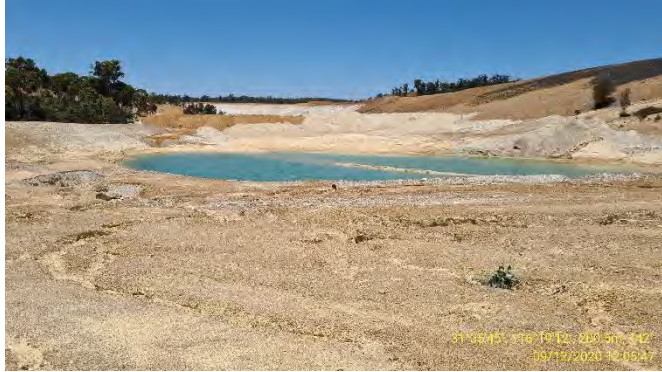
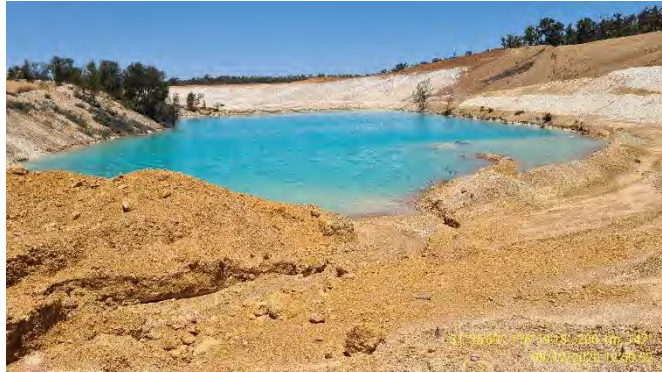
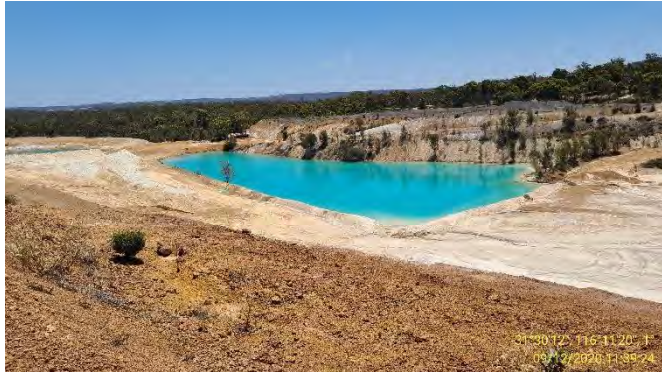
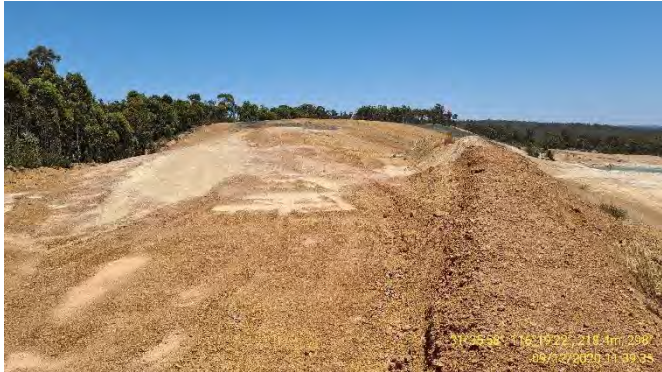
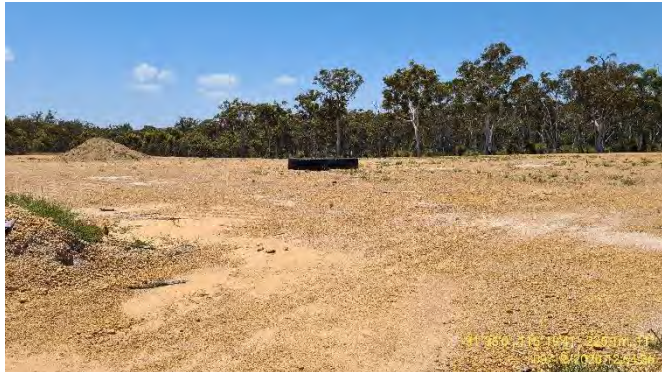
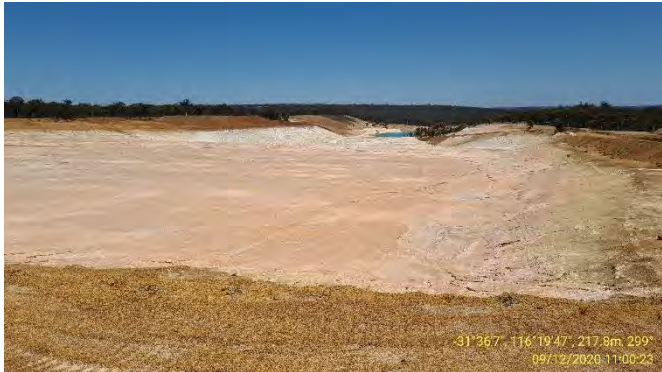
VEGETATION AREA	
AS 3959:2018 Vegetation Classification Applied:	Excluded as per Section 2.2.3.2 (e) Non Vegetated Areas
Vegetation Types Present:	Non-vegetated
Description/Justification:	Areas cleared for quarry site

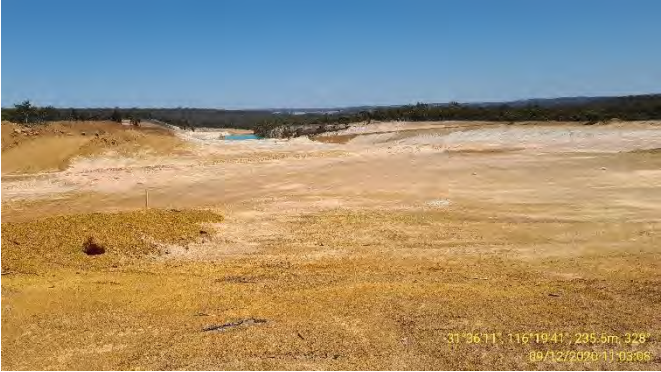
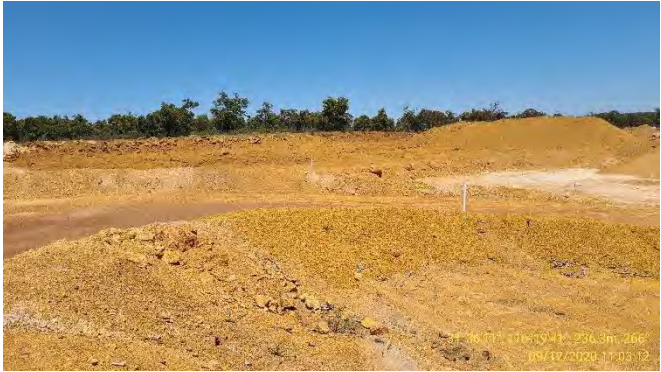
Photo ID: 7g	Photo ID: 7h

VEGETATION AREA	
AS 3959:2018 Vegetation Classification Applied:	Excluded as per Section 2.2.3.2 (e) Non Vegetated Areas
Vegetation Types Present:	Non-vegetated
Description/Justification:	Areas cleared for quarry site

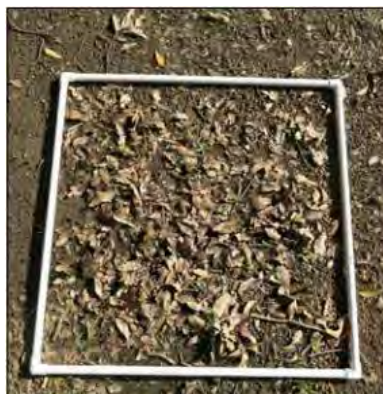
Fine Fuel Load: combustible dead vegetation matter less than 6 mm in thickness reduced to and maintained at an average of two tonnes per hectare (example below).

Example: Fine fuel load of 2 t/ha

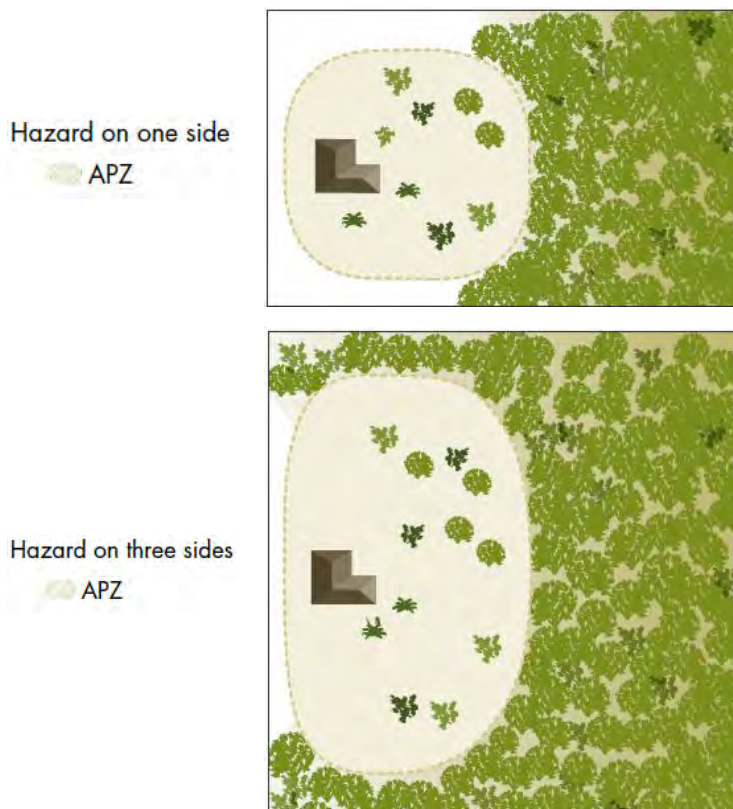
The following example diagrams illustrate how the required dimensions of the APZ will be determined by the type and location of the vegetation.
